Home Inspection Report

3855

Old Gordon Road
Atlanta, GA 30036

Inspected on Wed, Nov 18 2020 at 4:00 PM

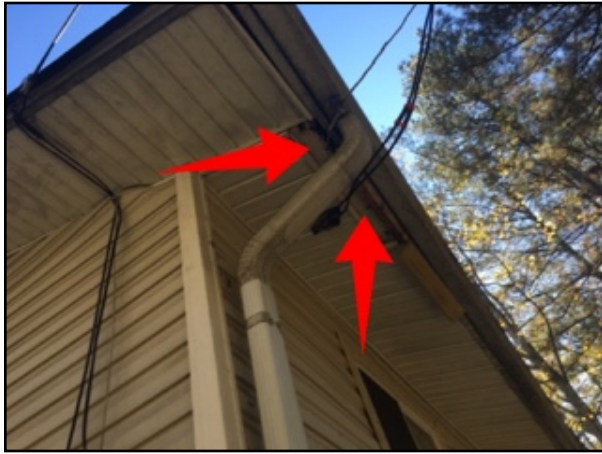
Figure 1-1

Comment 1:
Repair damaged soffit area.

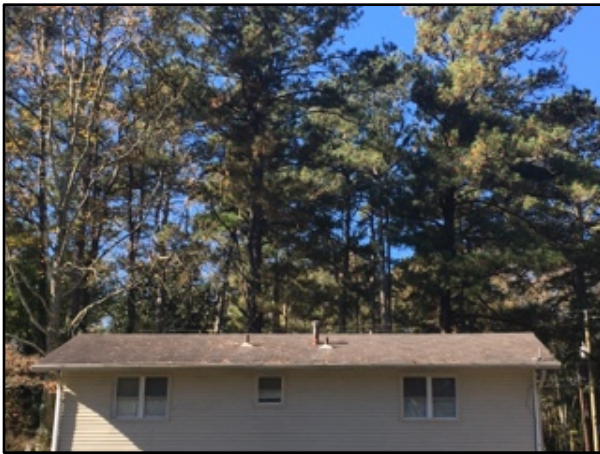
Figure 2-1

Roof is older room and could be replaced.

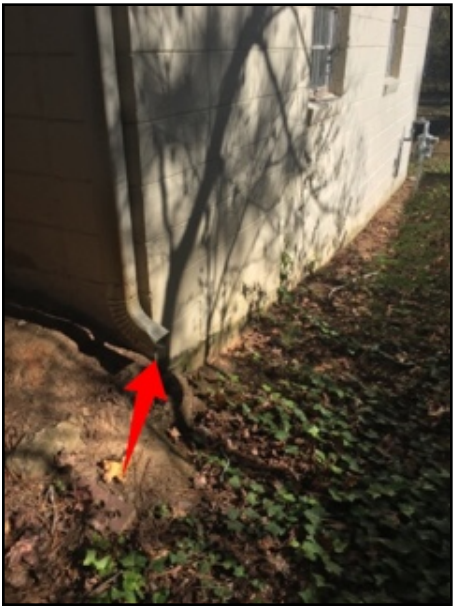
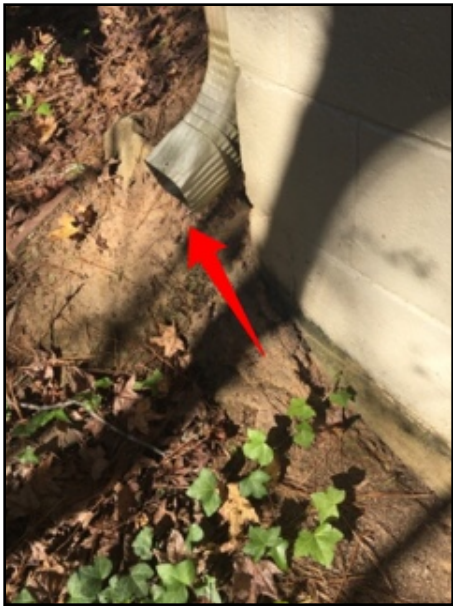
Comment 3:
Recommend adding gutter extensions.

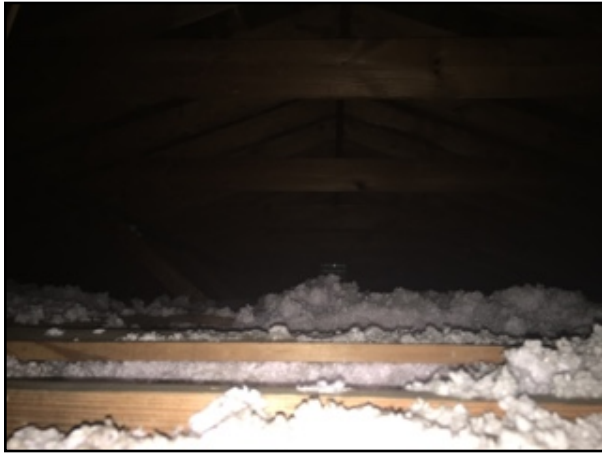
Figure 4-1

Comment 4:
Recommend adding more insulation in attic.

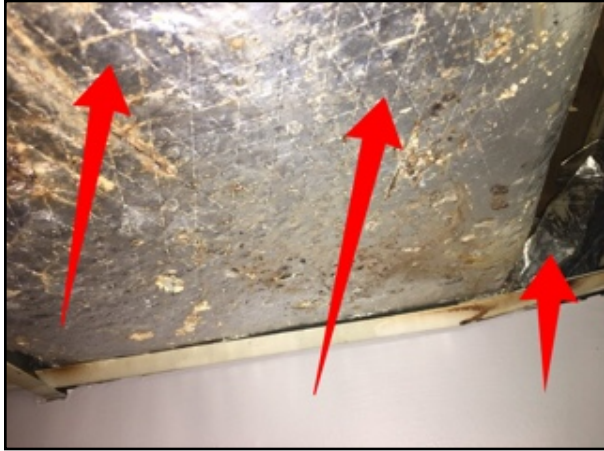
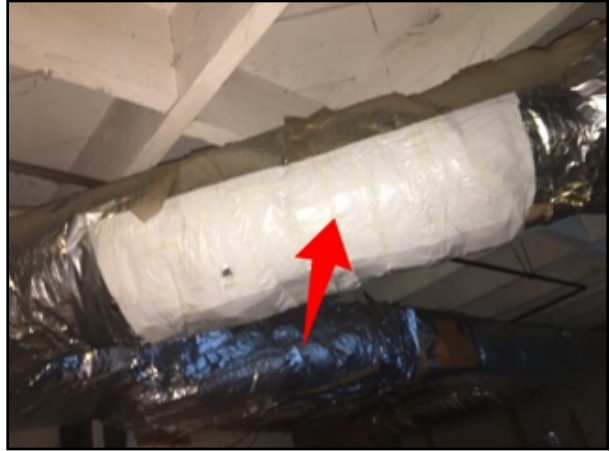
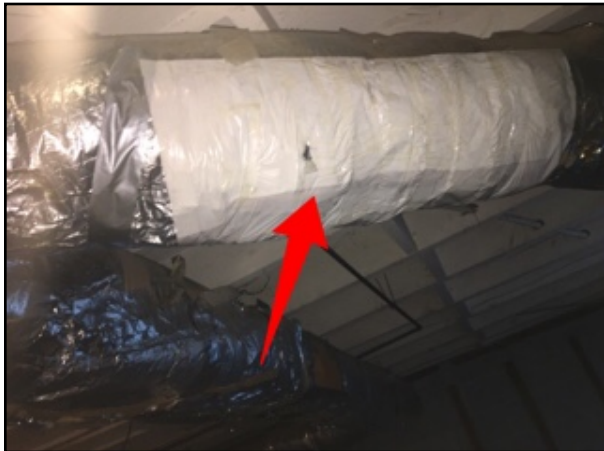
Comment 5:
Repair ducts in basement.

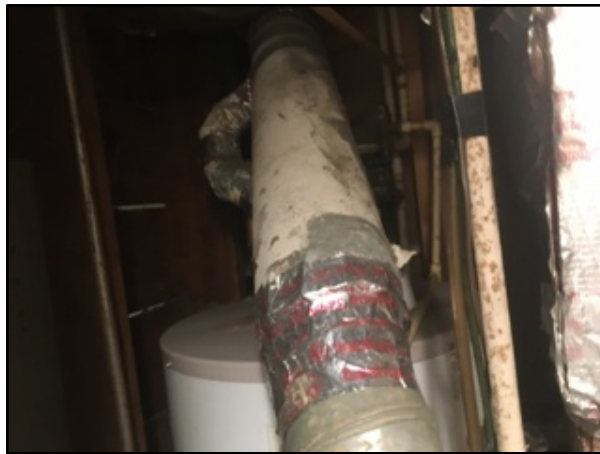
Comment 6:
Recommend adding drip pan.

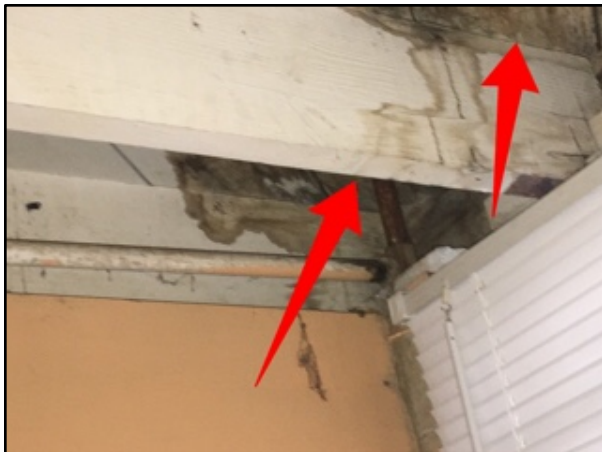
Figure 7-1

Repair leaks and water damage in basement. Repair holes in walls in basement.

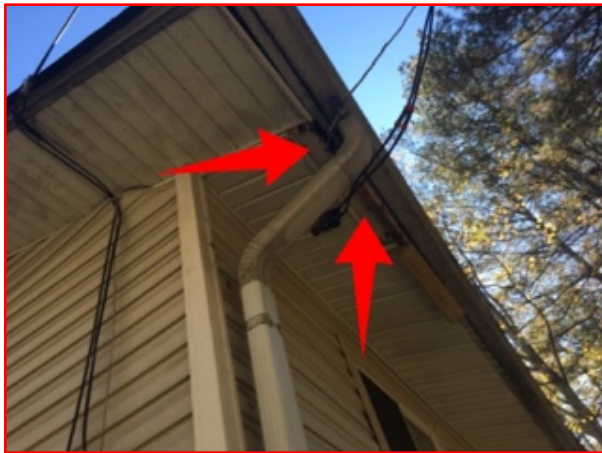
Figure 1-1

1) Repair damaged soffit area.

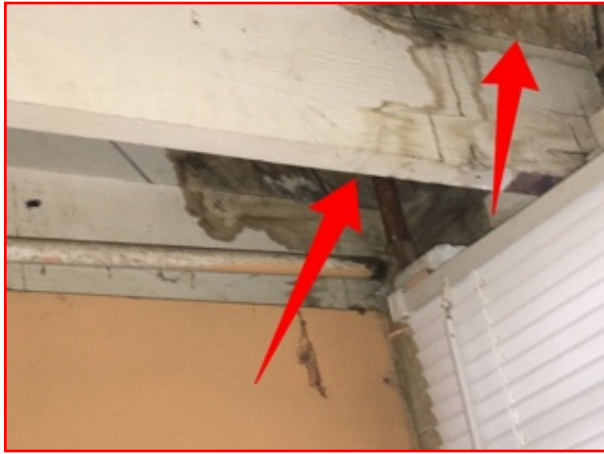
Figure 7-1

3) Repair leaks and water damage in basement. Repair holes in walls in basement.
