Home Inspection Report

2475

Bouldercliff Way

Inspected on Mon, Jul 20 2020 at 11:00 AM

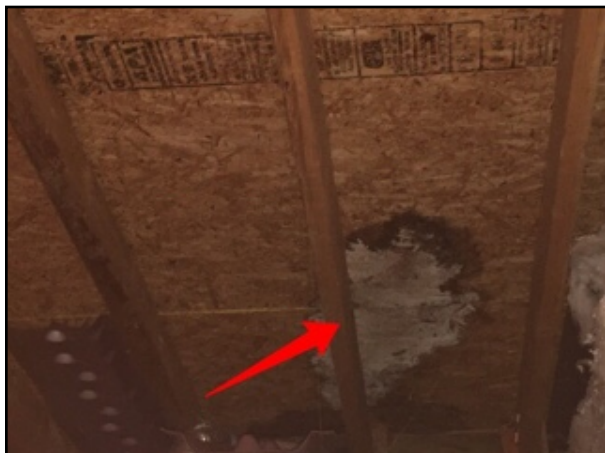
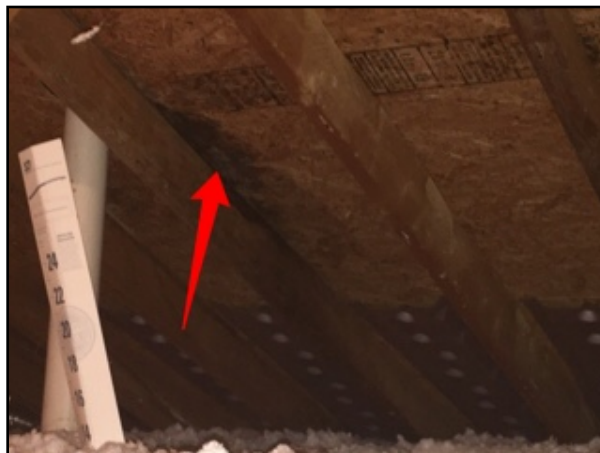
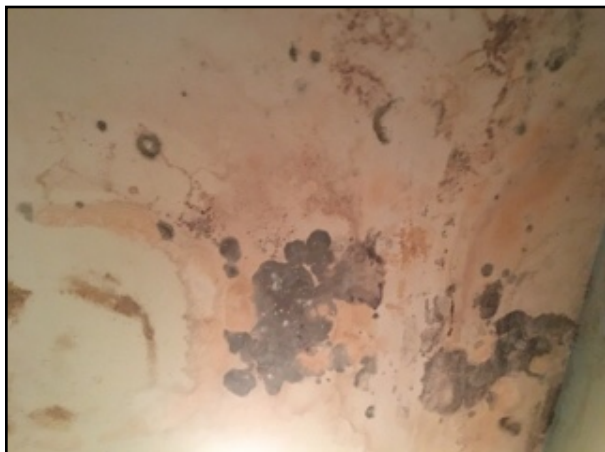
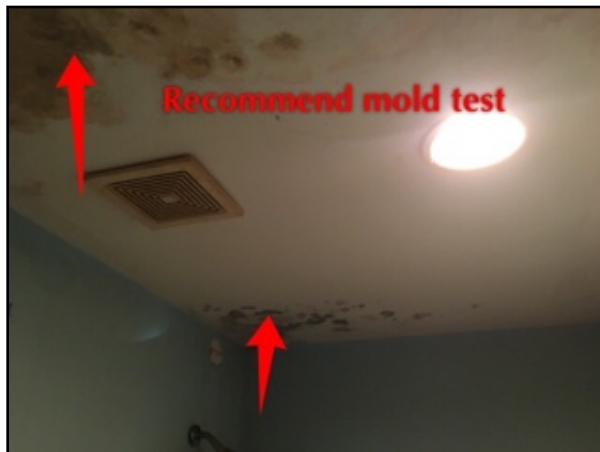
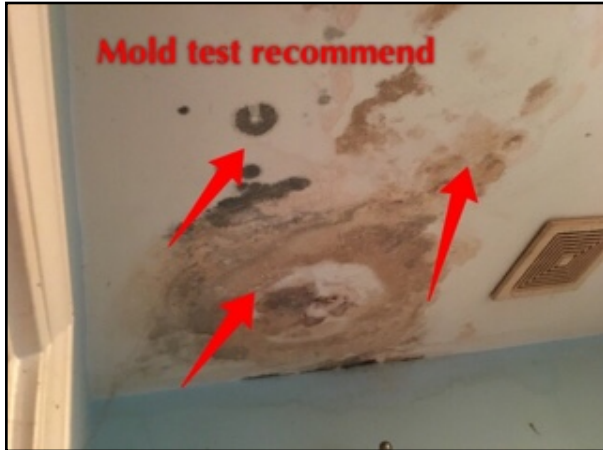
Comment 1:

Roof leaks needs to be repaired. Recommend mold test.

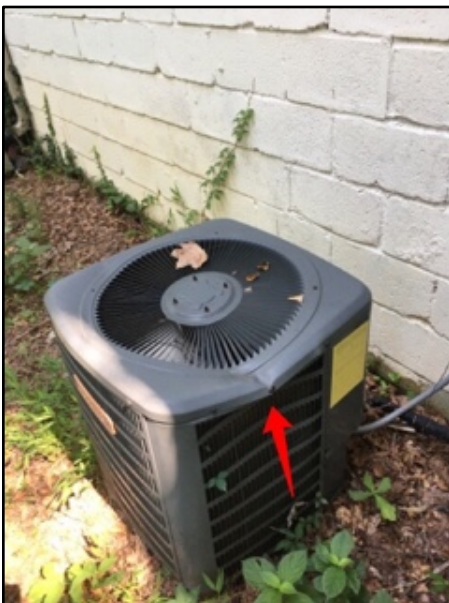
Figure 3-1

AC unit was hit by tree, but functioned on inspection. Recommend servicing based on age and condition.

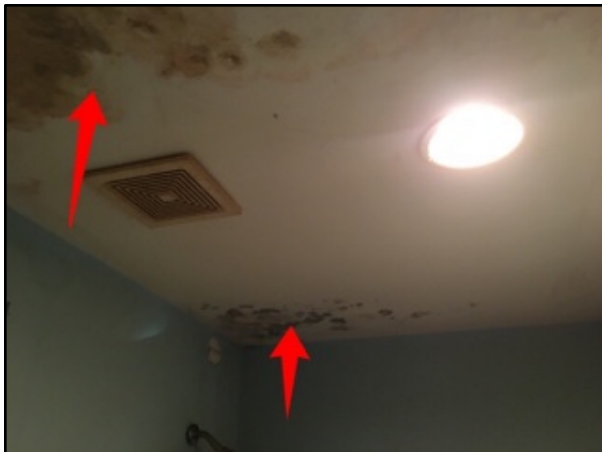
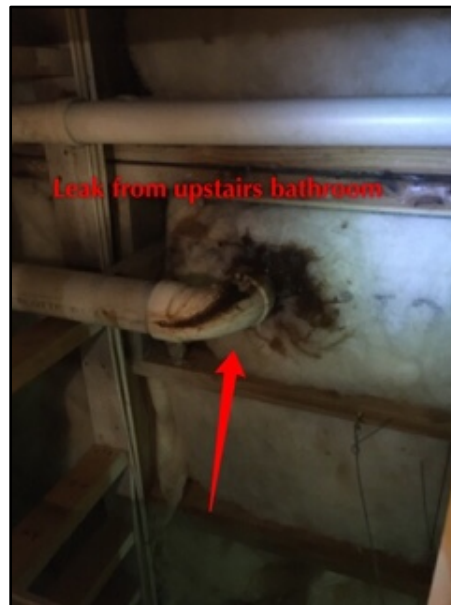
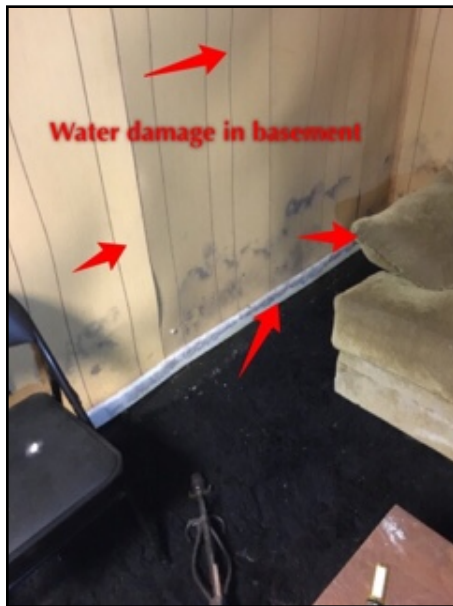
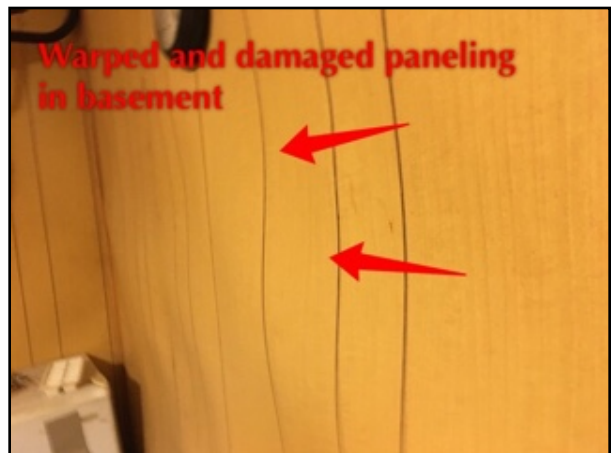
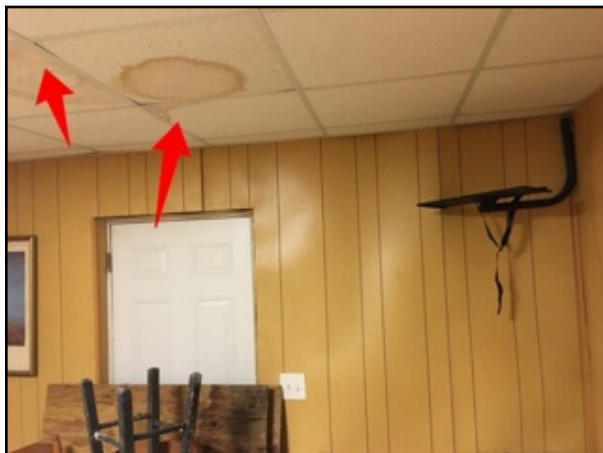
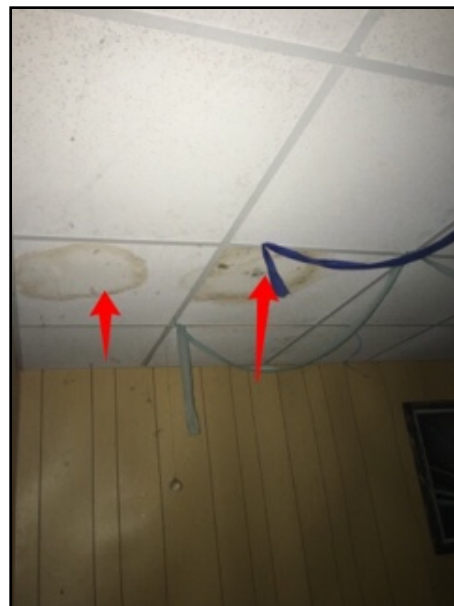
Comment 5:

Property has major water damage with possible mold. Recommend mold test.

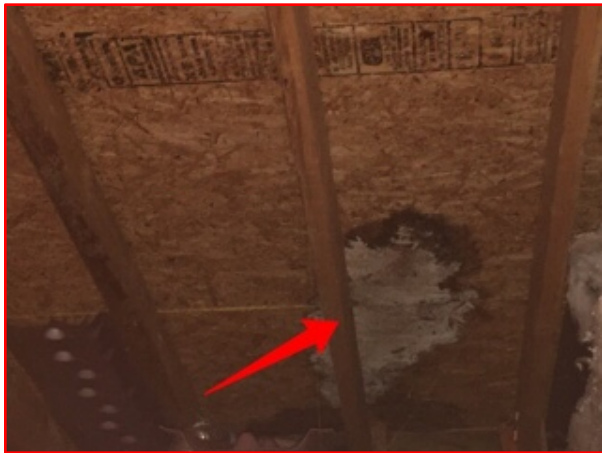
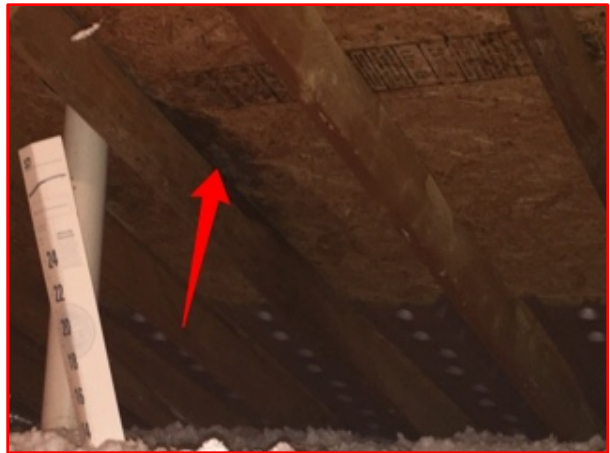
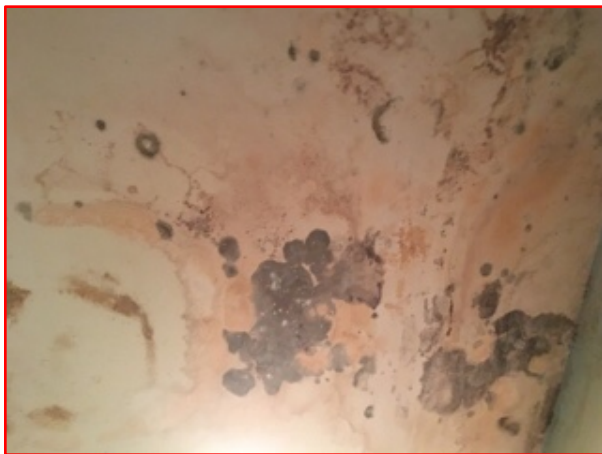
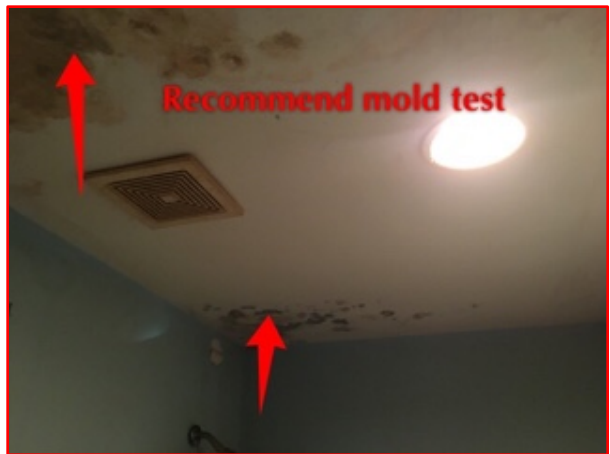
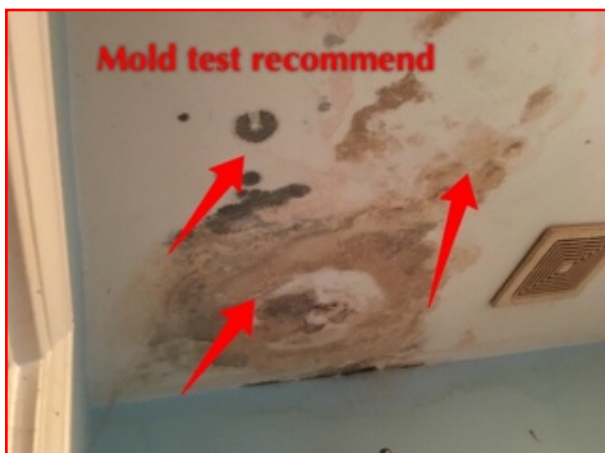
1) Roof leaks needs to be repaired. Recommend mold test.

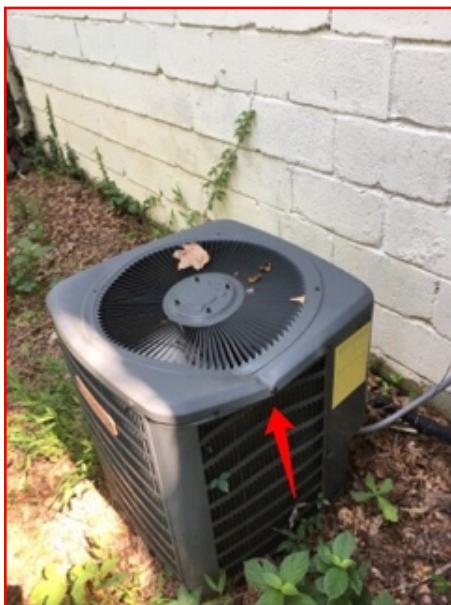
Figure 3-1

2) AC unit was hit by tree, but functioned on inspection. Recommend servicing based on age and condition.

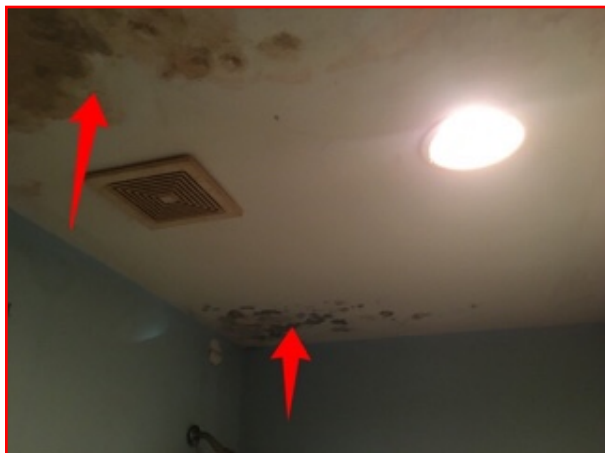
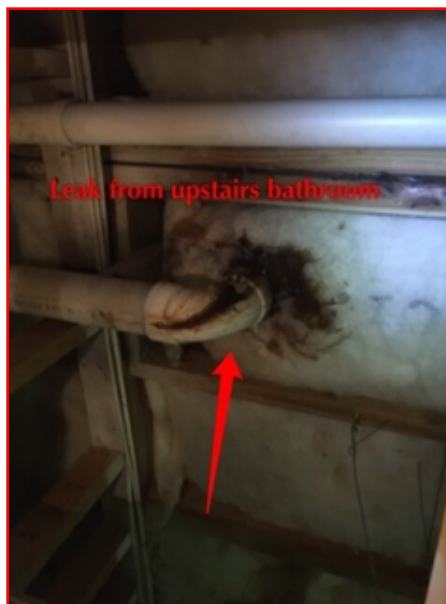
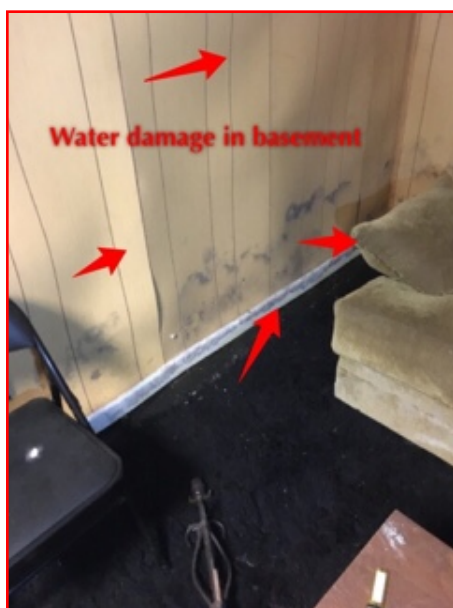
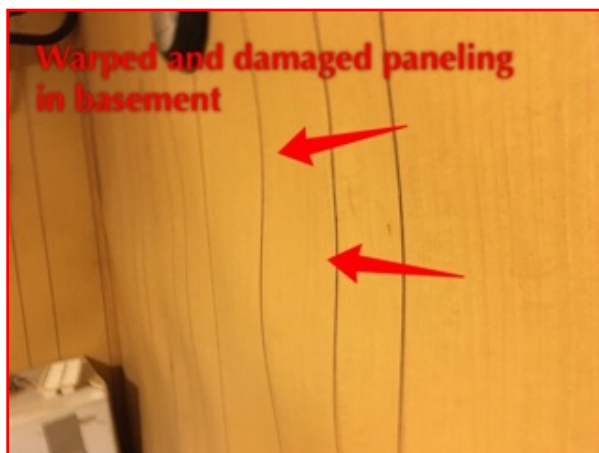
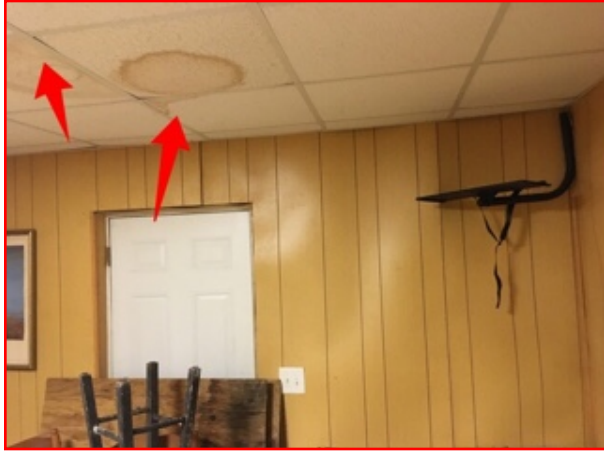
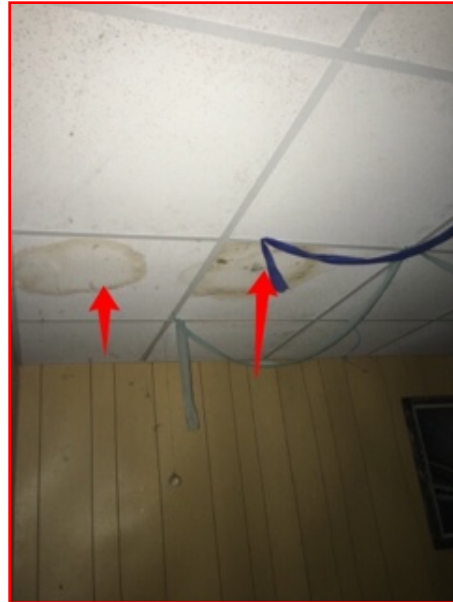
3) Property has major water damage with possible mold. Recommend mold test.
