## Home Inspection Report

Property Address:

**2305**

Inspected on Sat, Jul 11 2020 at 9:14 AM

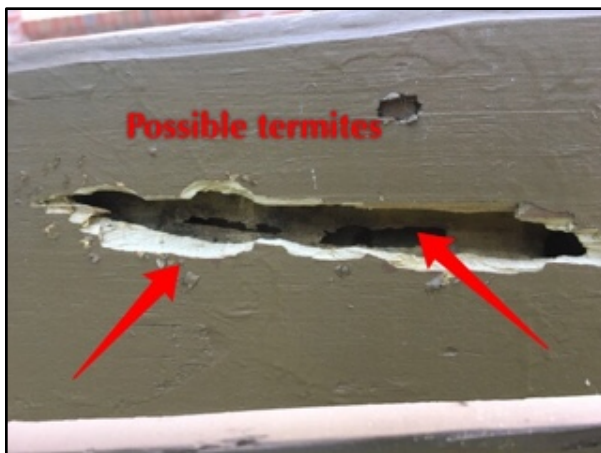
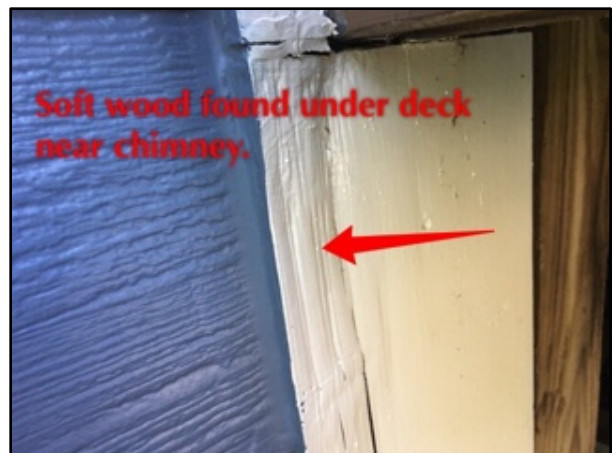
Comment 1:

Recommend getting termite inspection and bond. Rear deck has two areas of concern.

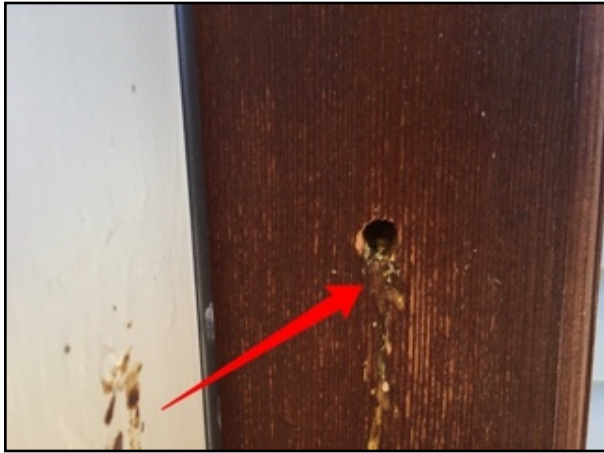
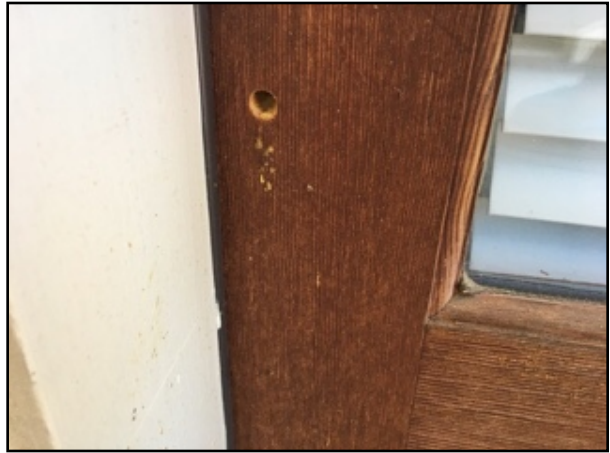
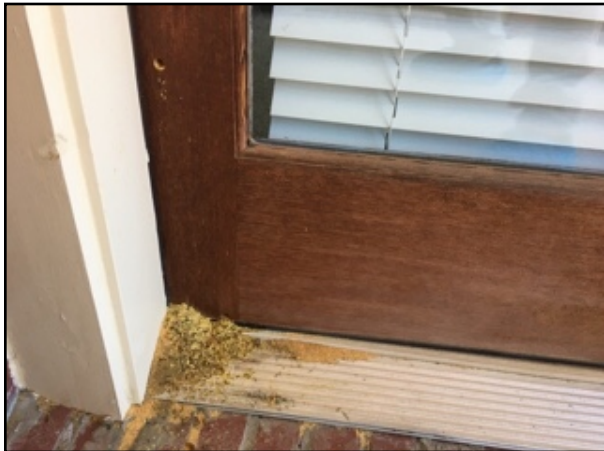
Comment 2:

Carpenter bees are putting holes in door on front patio.

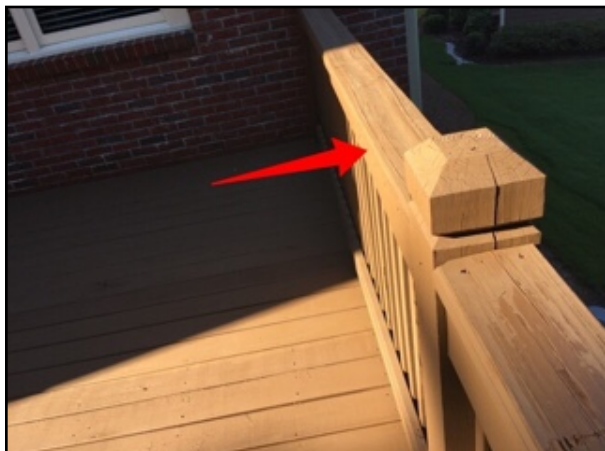
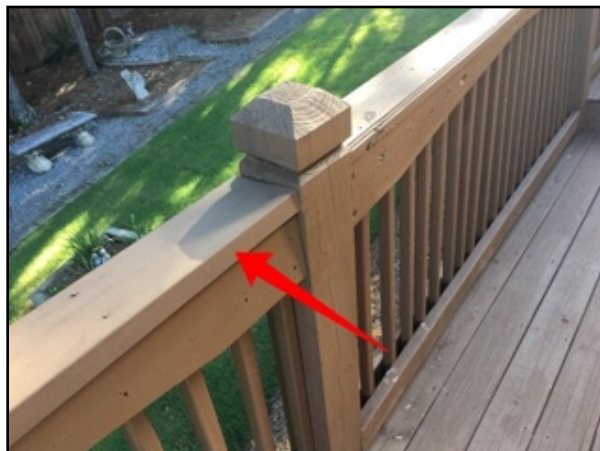
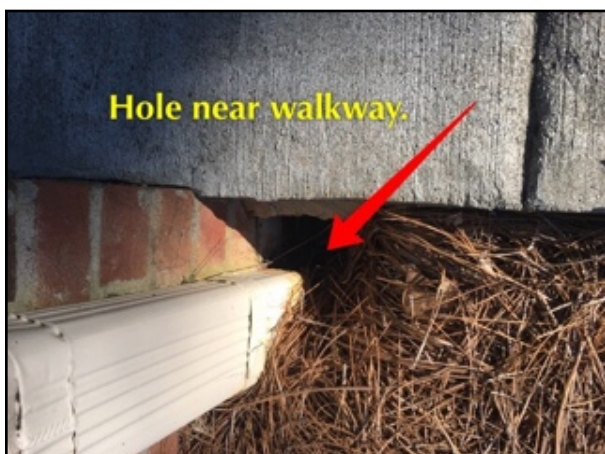
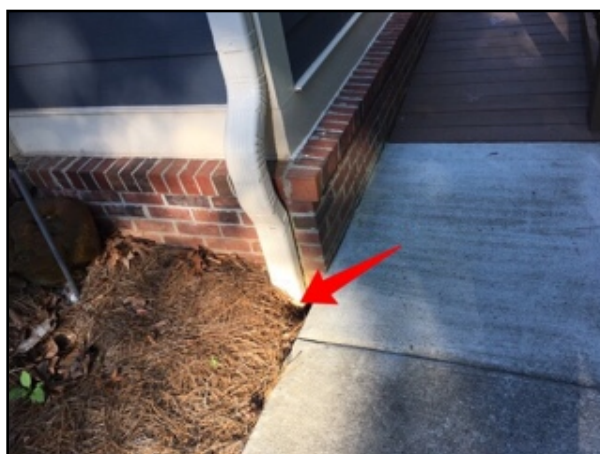
Comment 3:  
Repair loose railings on deck.

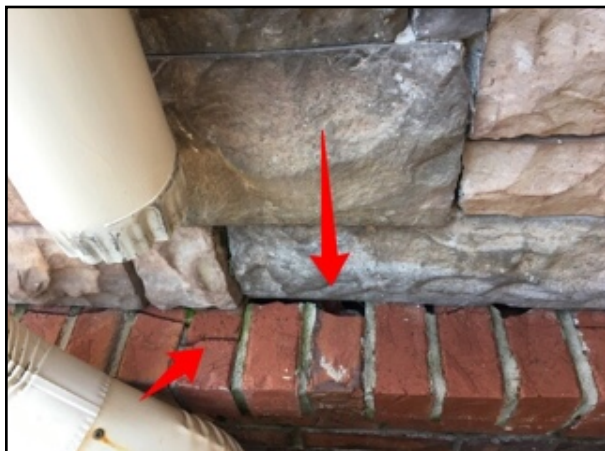
Figure 4-1

Brick cracked due to broken downspout and water intrusion.

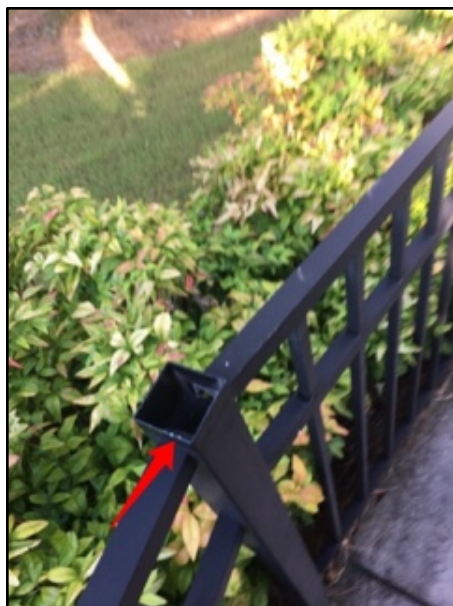
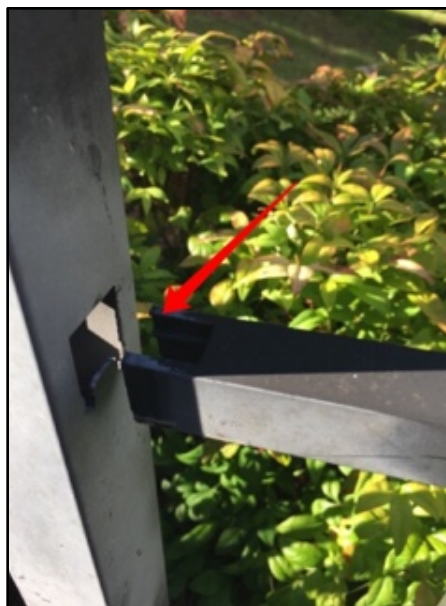
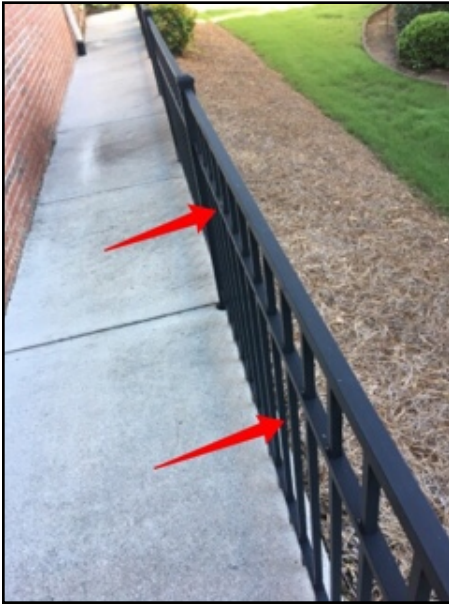
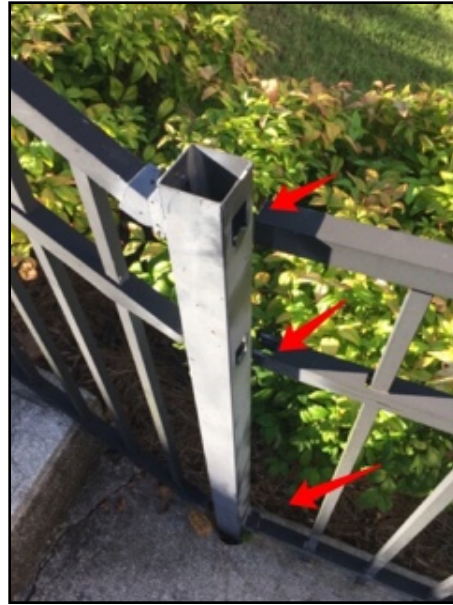
Repair loose gate around walkway.

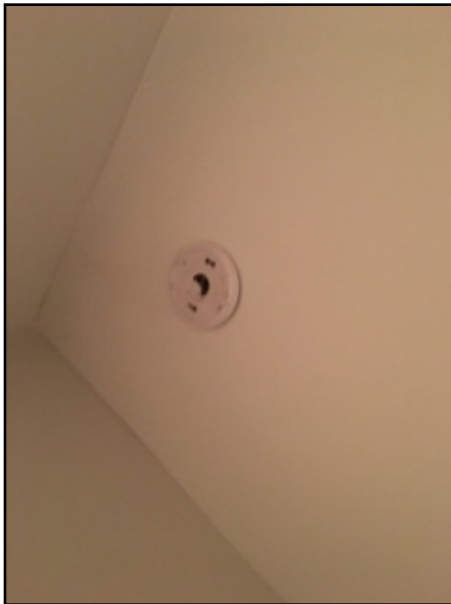
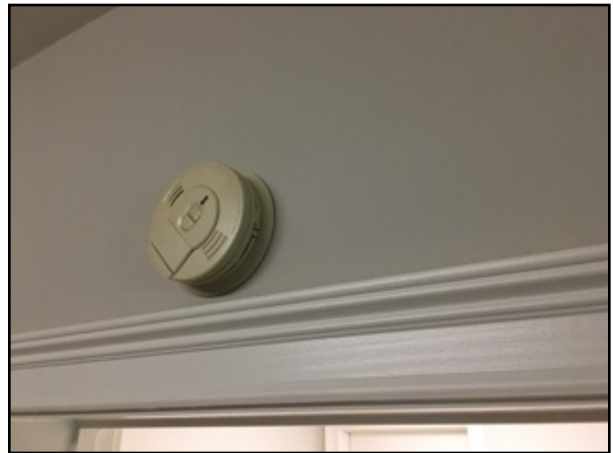
Several smoke detectors not connected, but majority are functioning correctly.

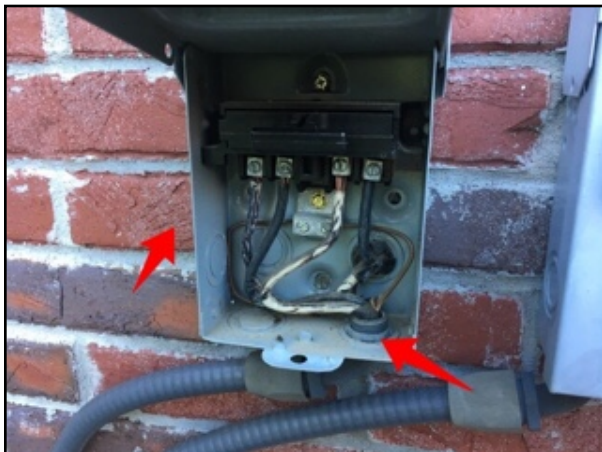
Figure 7-1

Install missing cover plate to AC unit main shut off.

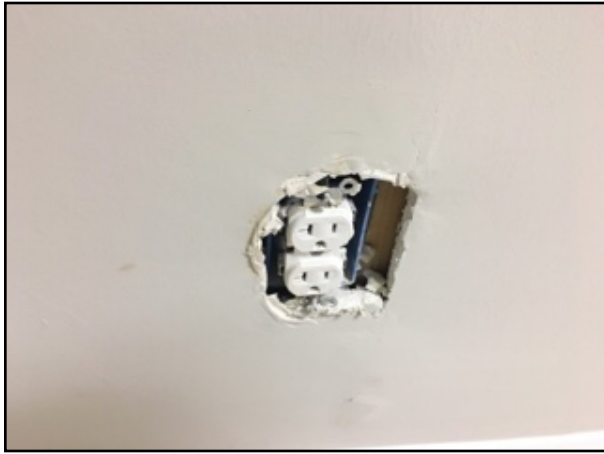
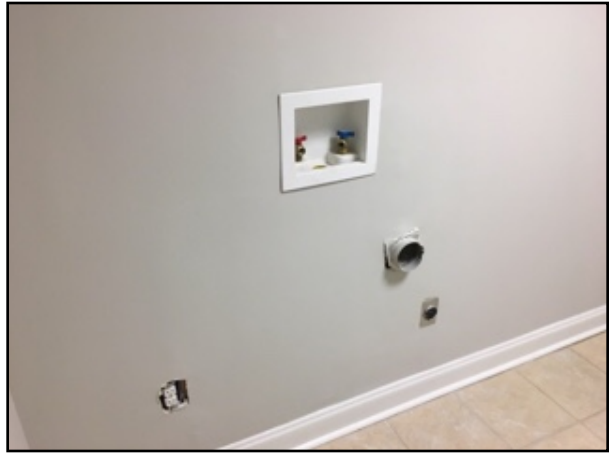
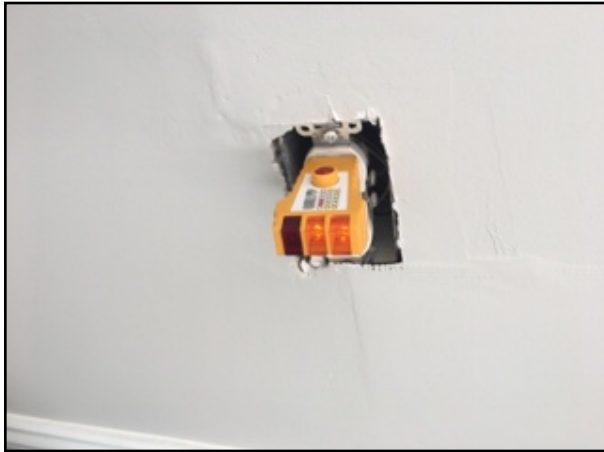
Comment 8:  
Repair missing outlet covers.

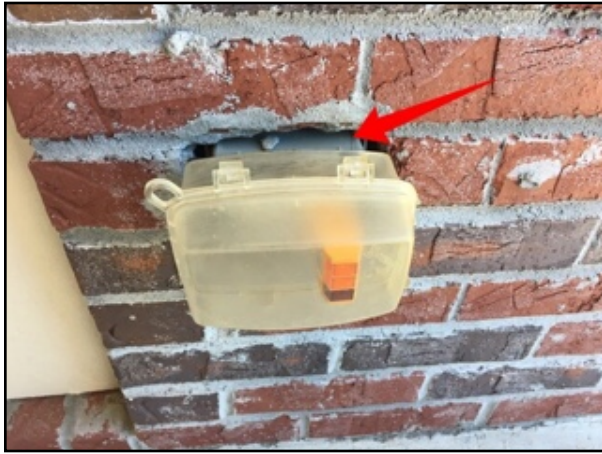
Figure 9-1

Repair loose outlet on upstairs bedroom balcony.

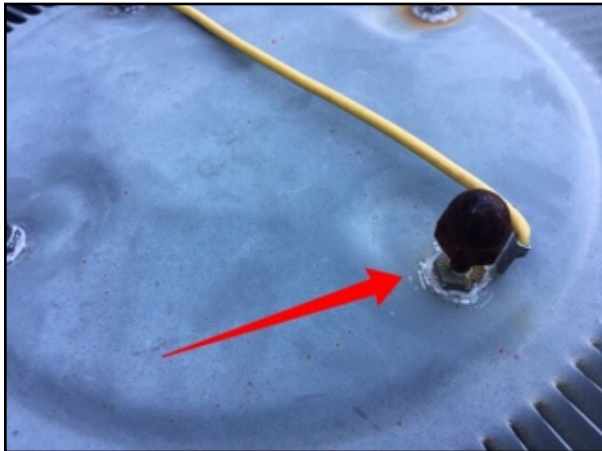
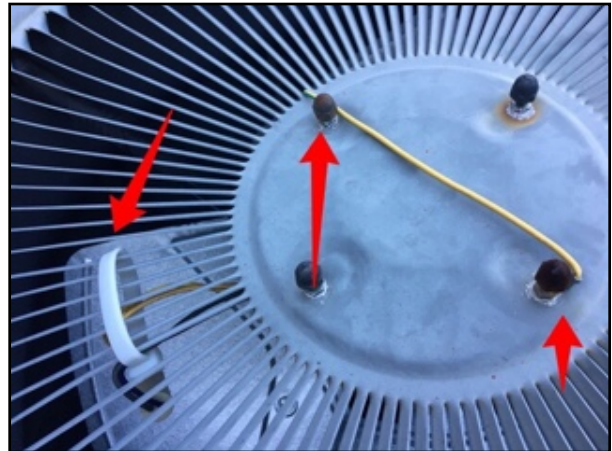
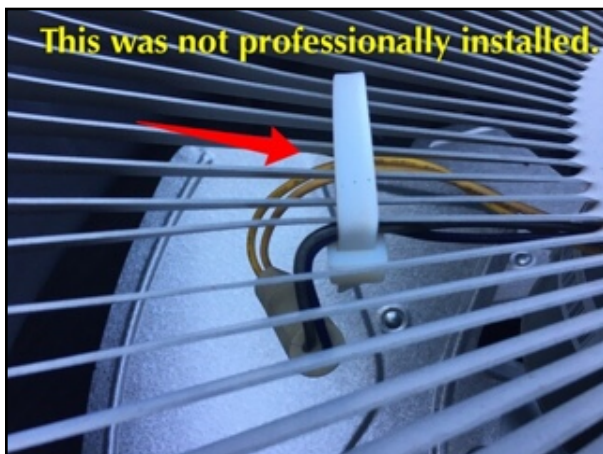
This should be grounded to inside not outside. Recommend being looked at and repaired by HVAC professional.

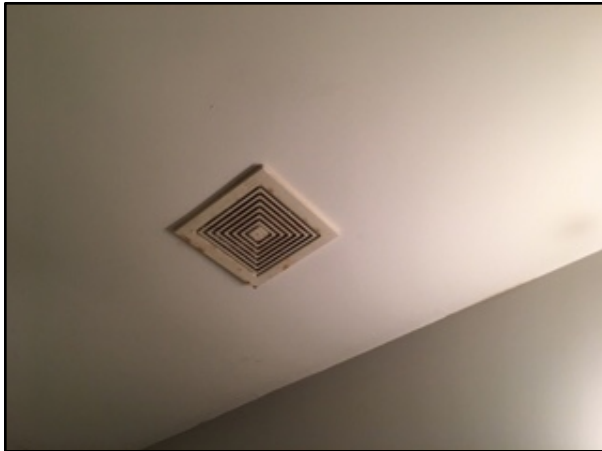
Figure 11-1

Comment 11:  
Replace ventilation in basement bathroom.

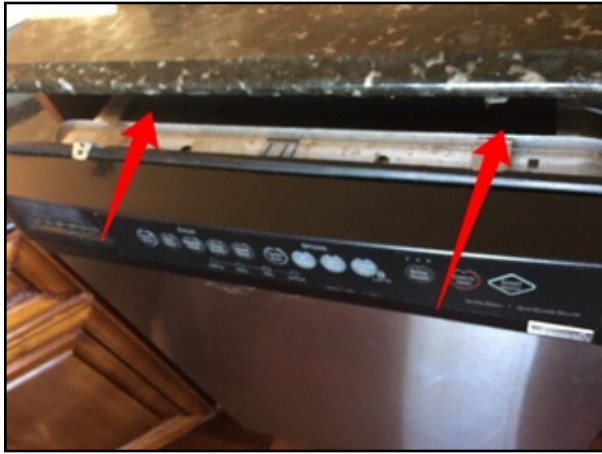
Figure 12-1

Comment 12:  
Dishwasher not properly attached to counter.

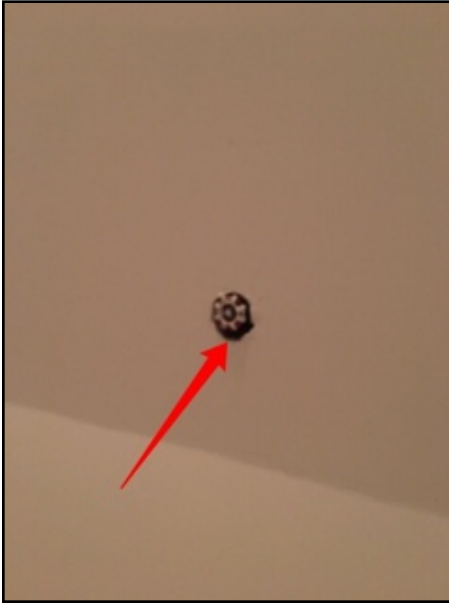
Figure 13-1

Comment 13:  
Unknown shut off in basement bedroom ceiling.

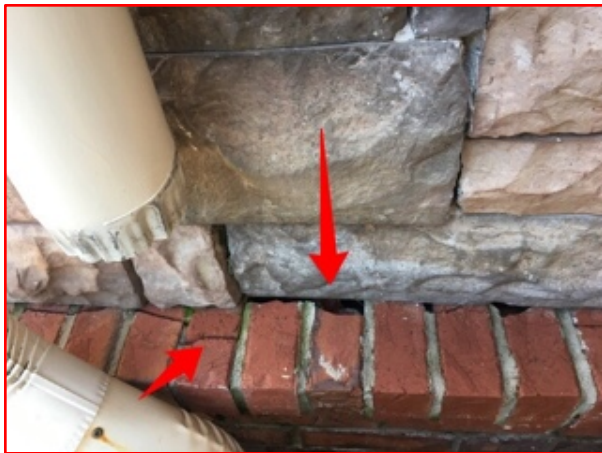
Figure 4-1

3) Brick cracked due to broken downspout and water intrusion.

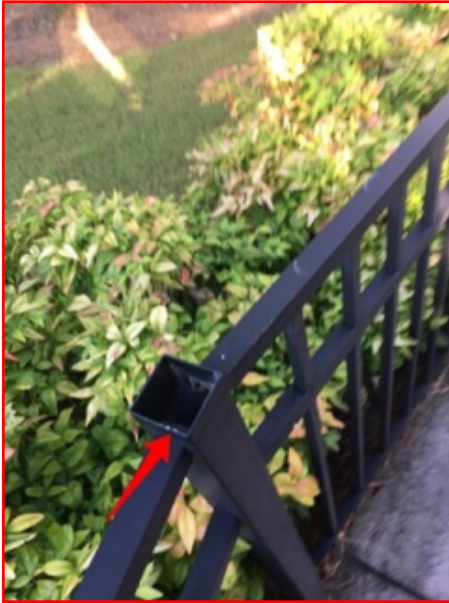
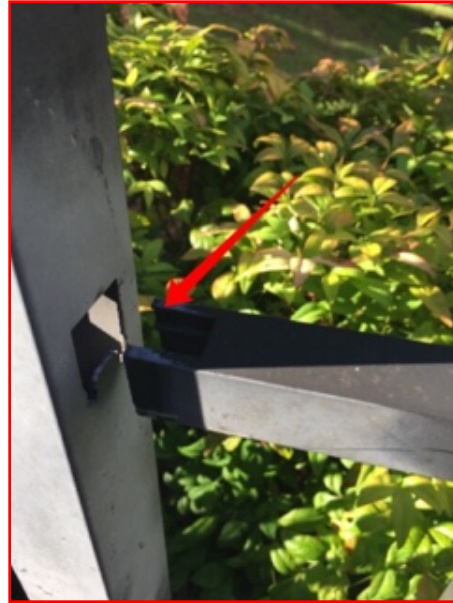
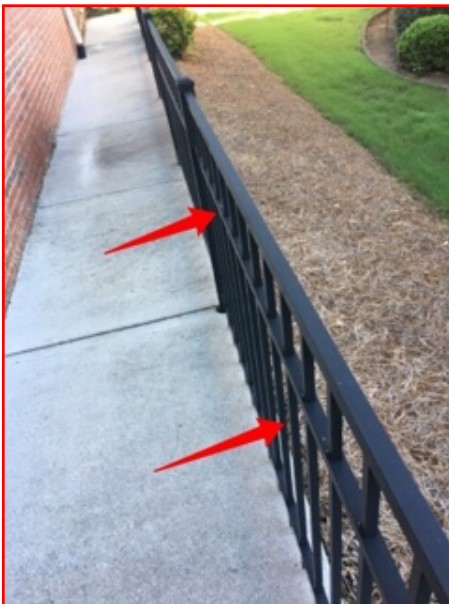
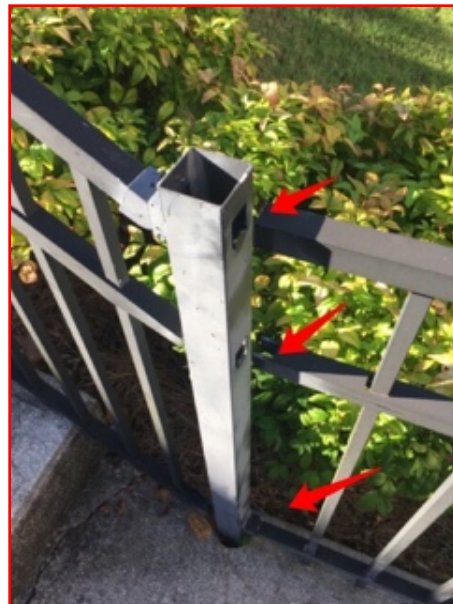
4) Repair loose gate around walkway.

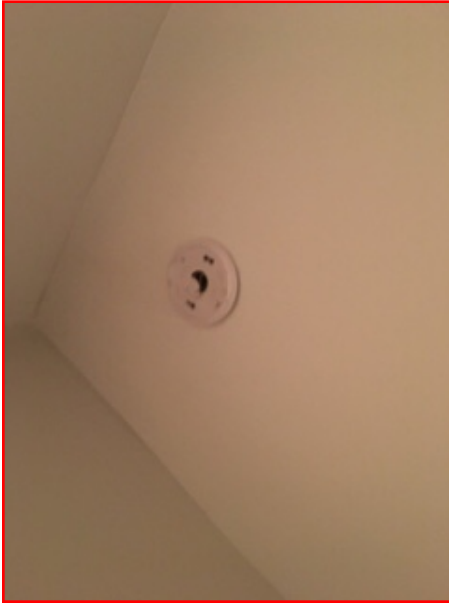
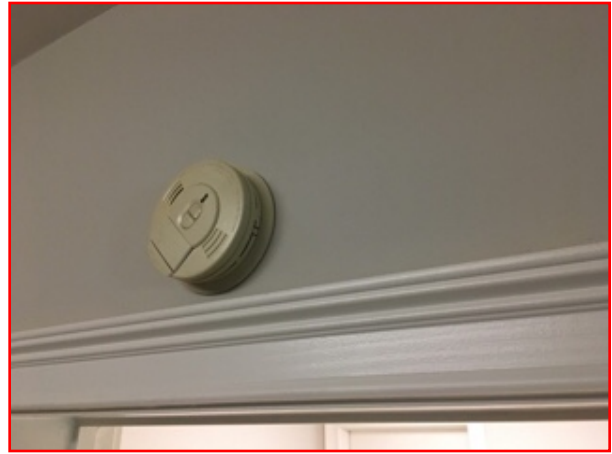
5) Several smoke detectors not connected, but majority are functioning correctly.

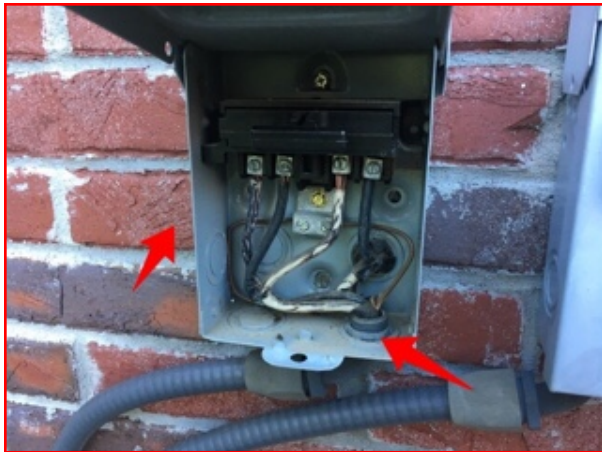
Figure 7-1

6) Install missing cover plate to AC unit main shut off.

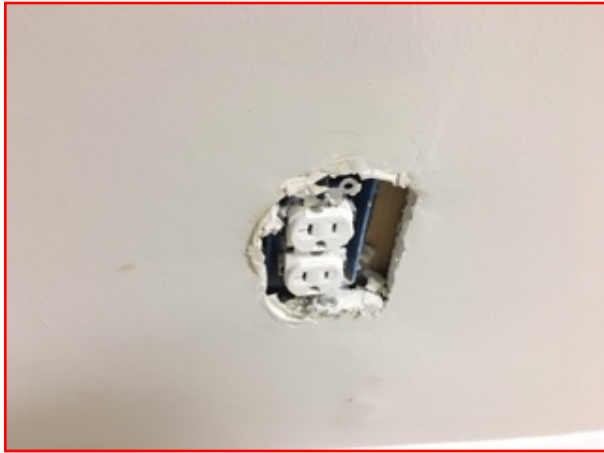
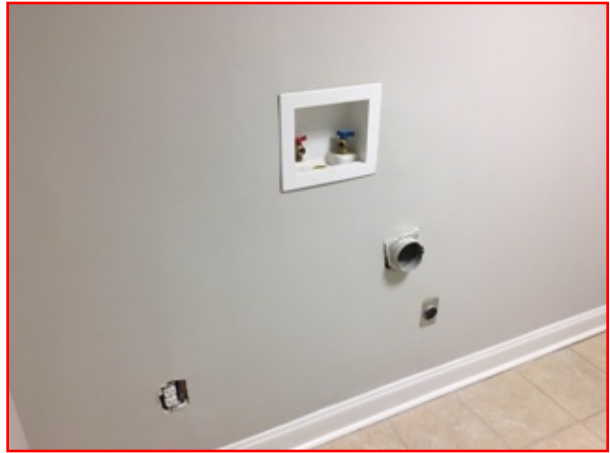
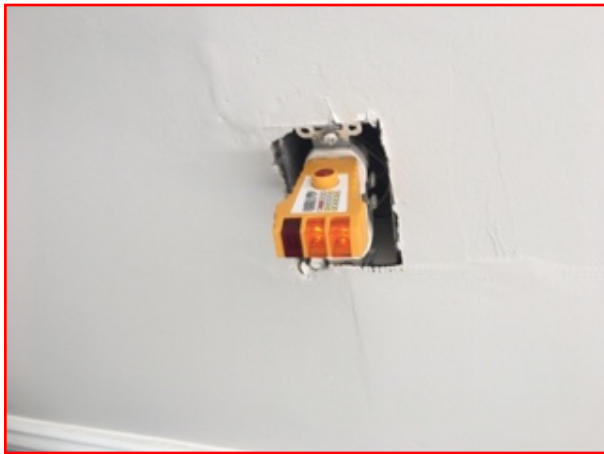
7) Repair missing outlet covers.

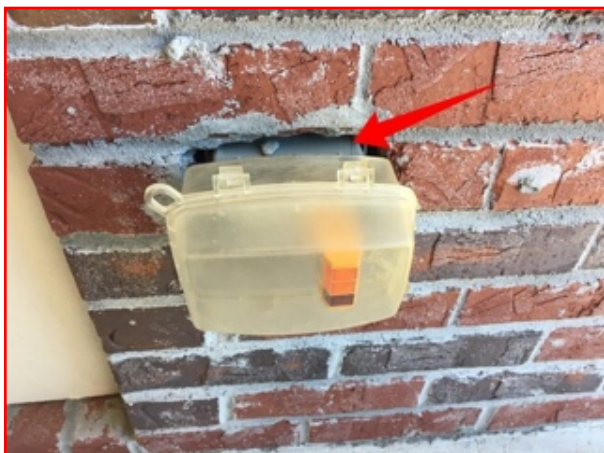
Figure 9-1

8) Repair loose outlet on upstairs bedroom balcony.

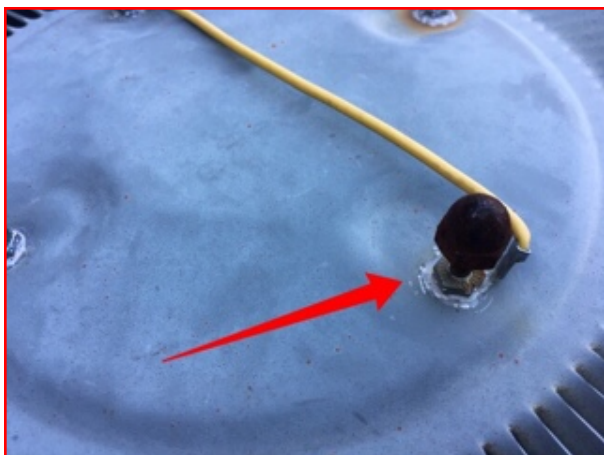
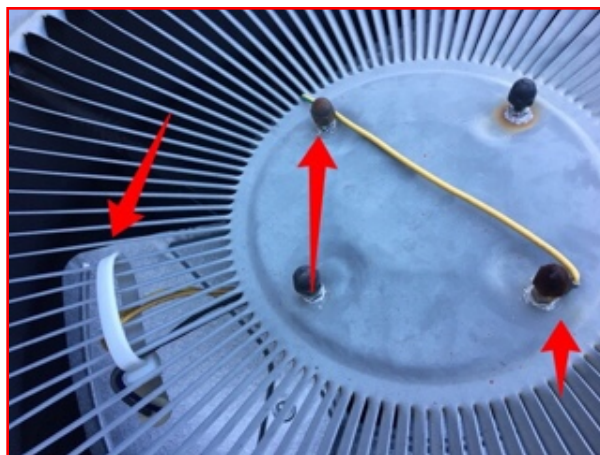
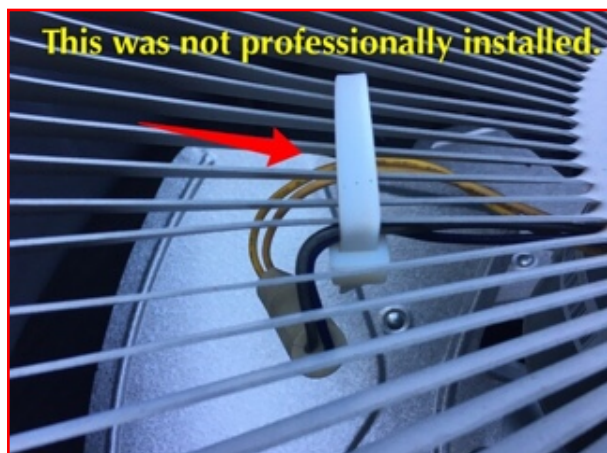
9) This should be grounded to inside not outside. Recommend being looked at and repaired by HVAC professional.

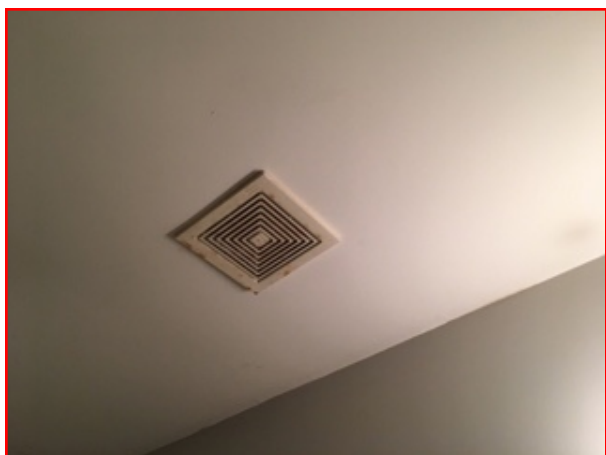
Figure 11-1

10) Replace ventilation in basement bathroom.

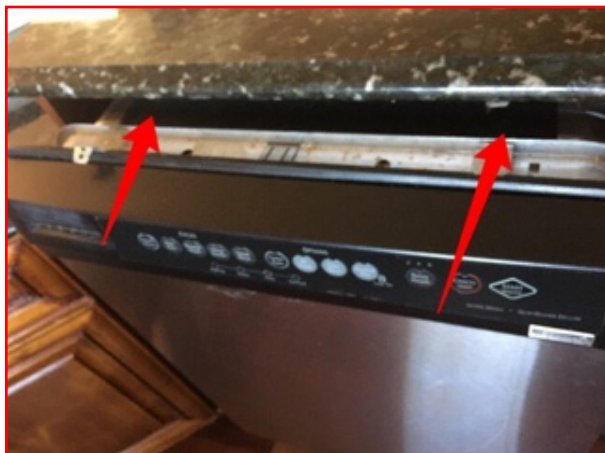
Figure 12-1

11) Dishwasher not properly attached to counter.
